**Hob Lane Solar Farm**  
**Historic Environment Assessment Report**  
**April 2025**  
**Hob Lane Solar Farm Ltd**

Client	Hob Lane Solar Farm Ltd	
Site name	Hob Lane Solar Farm	
Report type	Historic Environment Assessment Report	
Report reference	P00203.01	
Report date	April 2025	
Prepared by	Helena Kelly, BSc, MCIfA	
	Heritage Archaeology Harborough Innovation Centre Airfield Business Park, Leicester Rd, Market Harborough LE16 7WB	
Revision history	A	Client draft
	B	Updates following client review (07/04/2025)

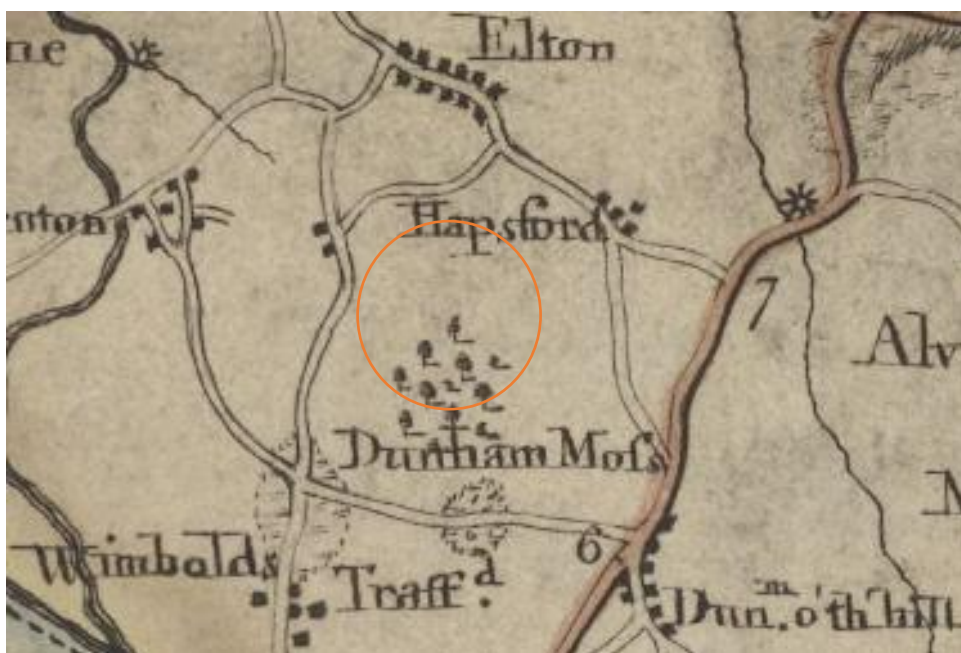
Figure 2: Burdett's Map of the County Palatine of Cheshire, 1794  
(Reproduced with the permission of the National Library of Scotland)

- 3.12. The area of the Site is shown on Burdett's map of Cheshire 1794 as within an area of land between the settlements of Elton, Hapsford and Dunham-on-the-Hill.

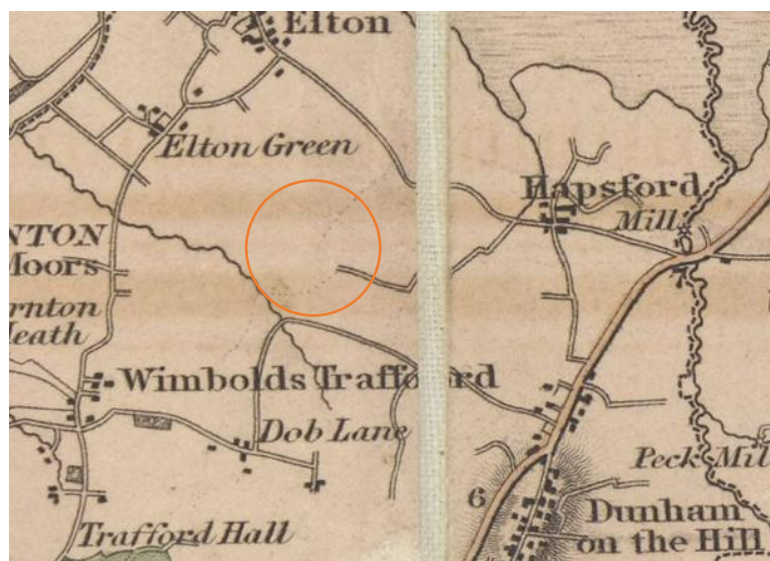
Figure 3: Swire, William. Hutchings, W. F. A map of the county palatine of Chester, 1828 and 1829  
(Reproduced with the permission of the National Library of Scotland)

- 3.17. The 1830 map of Cheshire by Swire and Hitchings shows the site with Rake Lane and Common Lane shown. No buildings are depicted within the application site.

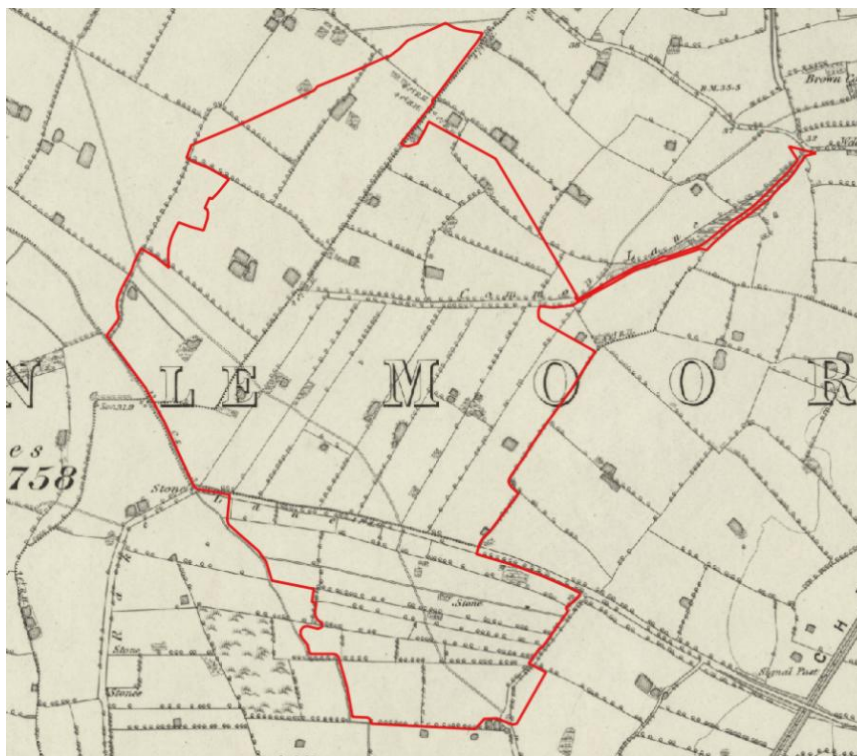
Figure 4: Ordnance Survey County Series, 1873, 1:10,560

3.18. The Ordnance Survey historic map series shows the changes to the field pattern within the application site as the fields were amalgamated for more modern farming techniques, but the ROF site is not shown until later 20<sup>th</sup> century mapping. It is common for military infrastructure to be omitted from mapping. The ROF buildings and rail track can however be seen in aerial images of the ROF site from the mid-20<sup>th</sup> century.

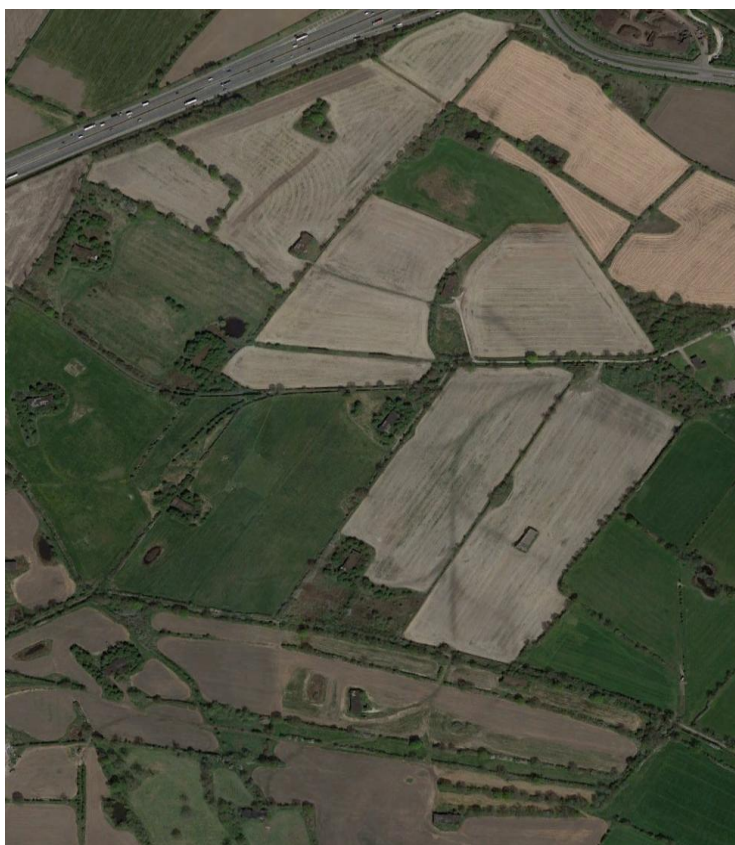
Figure 10: Google Earth aerial image  
2021

- 3.24. The extant buildings correspond to the 1945 aerial images, with one no longer having the bund shown in the historic aerial image (ID 9).
- 3.25. Additional buildings were identified during the walkover survey within the application site, comprising two small brick structures which may have been a sentry box and store or mess building and a larger brick store. Only one small section of in situ rail track was noted, in the extant track to the west of Common Lane (photographs, location and descriptions provided in Appendix B).

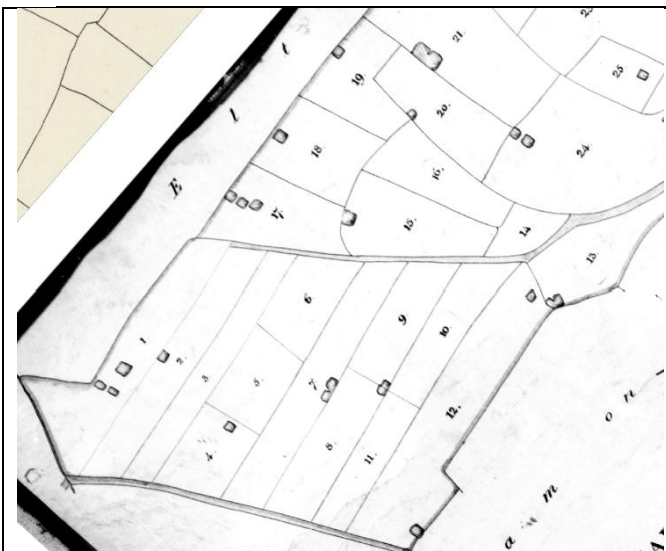
Hapsford

- 3.13. The historic land use of the proposed development site is first documented in the post medieval period; 19<sup>th</sup> century mapping of the site shows it as a series of small enclosed fields. This is shown on the tithe map and apportionment, included as **Appendix A**, below. The enclosure pattern is different to the modern pattern, with smaller fields including field names such as 'Moss Field', which indicates that part of the site was enclosed from marginal land that formed part of Dunham Moss. The historic mapping shows a large number of ponds within the application site, which may be associated with marl pits, used to improve the land for agricultural purposes.

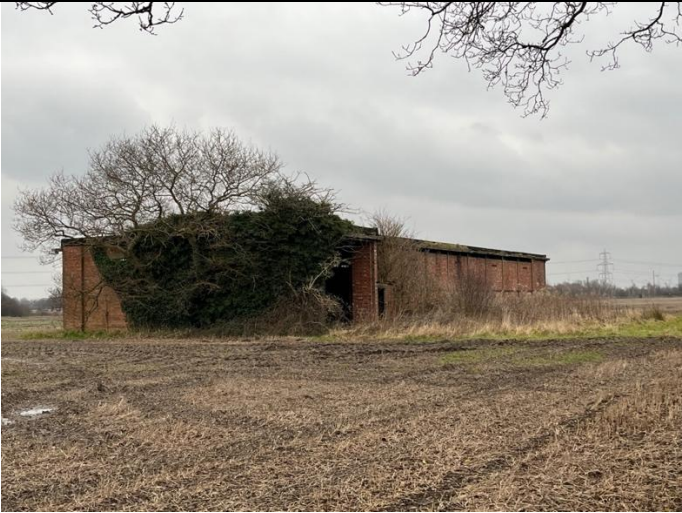
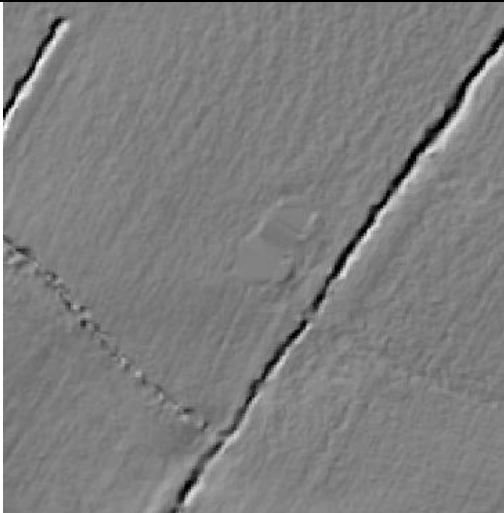
<p>ID: 1</p> <p>Description: No bund or tracks (no bund on historic AP, which shows single track leading into building).</p> <p>Condition: Fair/overgrown</p>

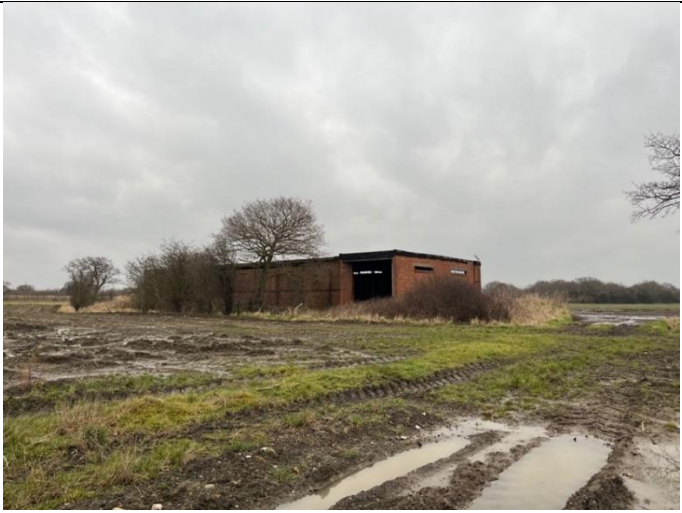
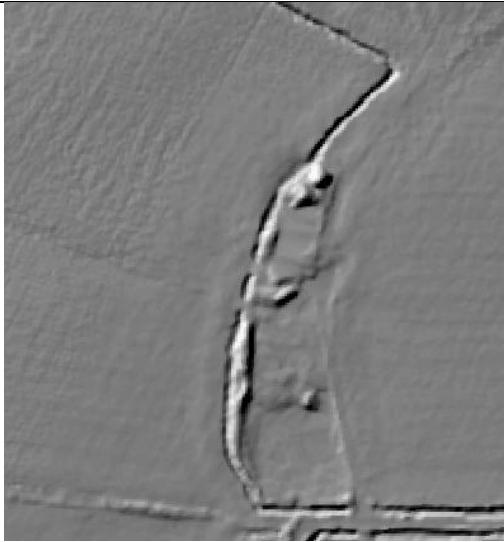
<p>ID: 2</p> <p>Description: No bund or tracks (no bund on historic AP, which shows single track leading into building).</p> <p>Condition: Fair</p>

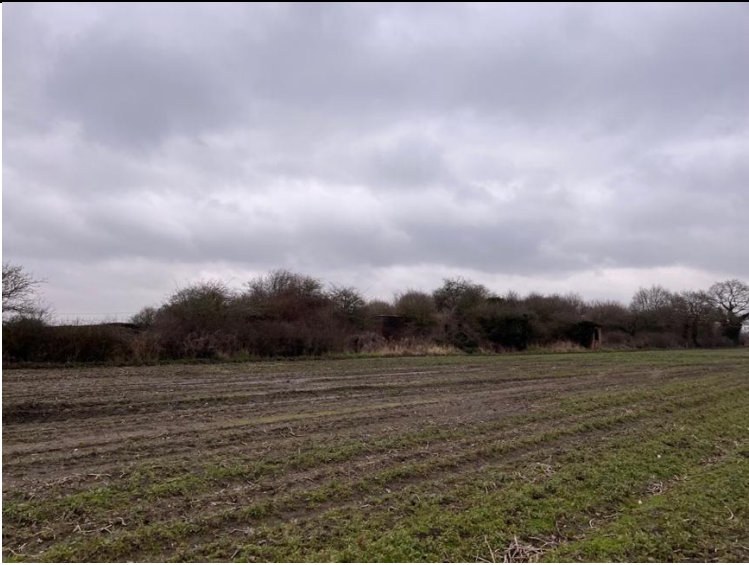
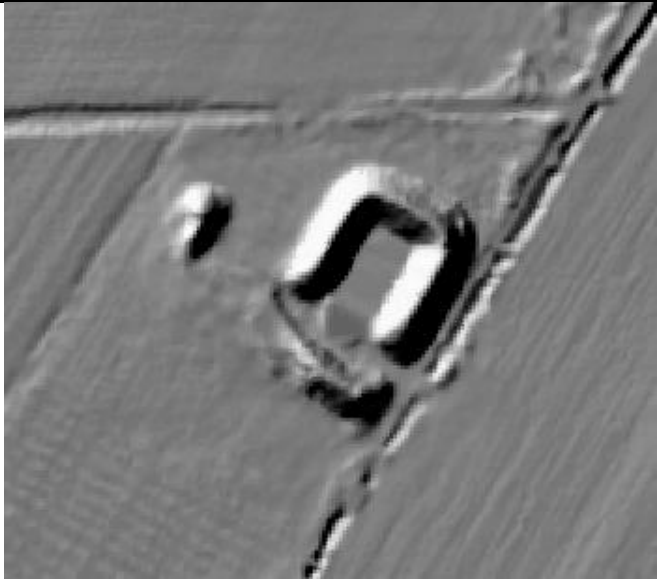
<p>ID: 5</p> <p>Description: Large bund with no track surviving. Bund shown on historic AP.</p> <p>Condition: good but overgrown</p>

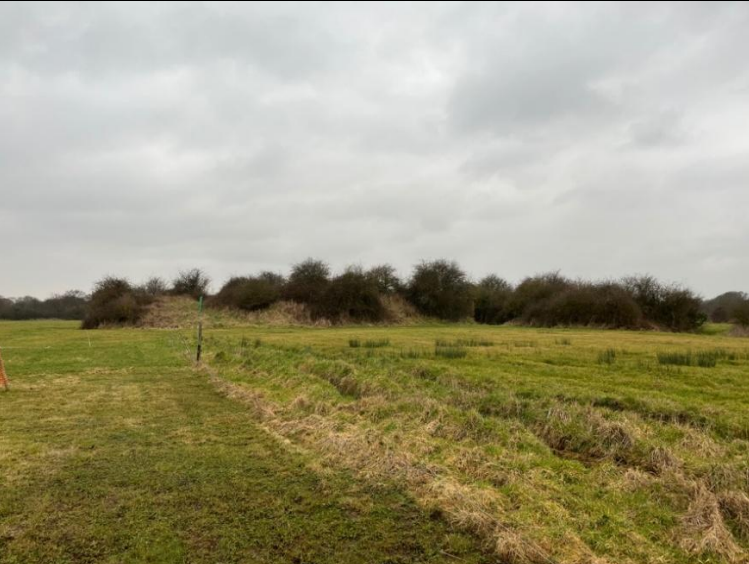
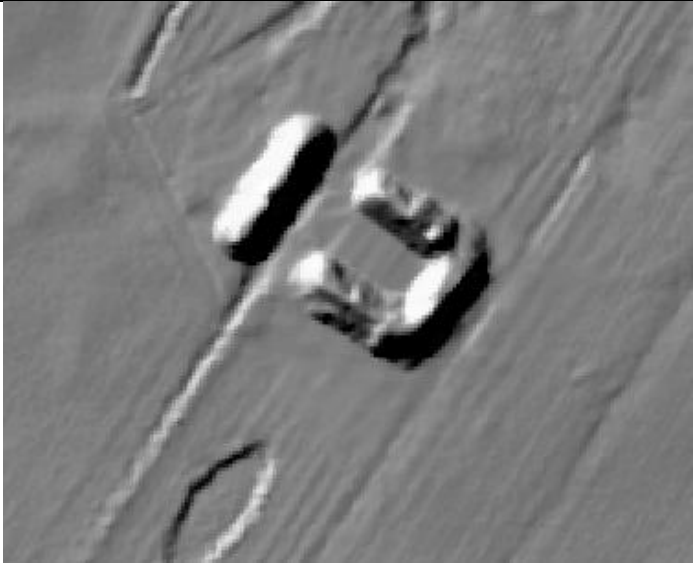
<p>ID: 6</p> <p>Description: Large bund with no track surviving. Bund shown on historic AP.</p> <p>Condition: good but overgrown</p>

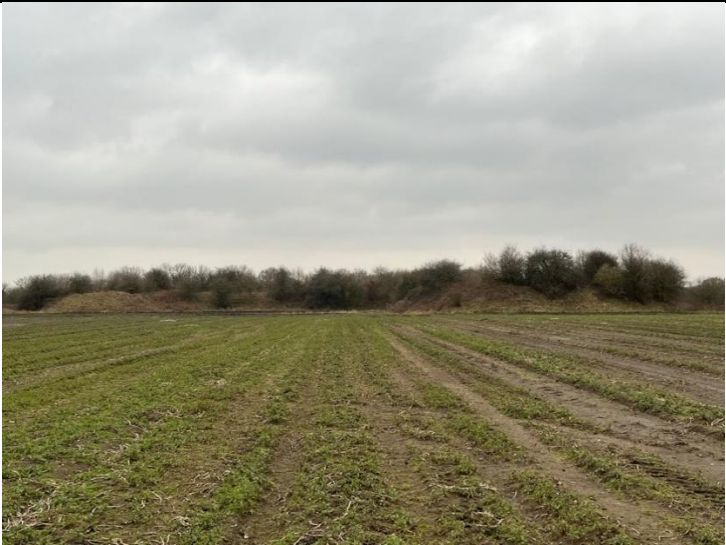
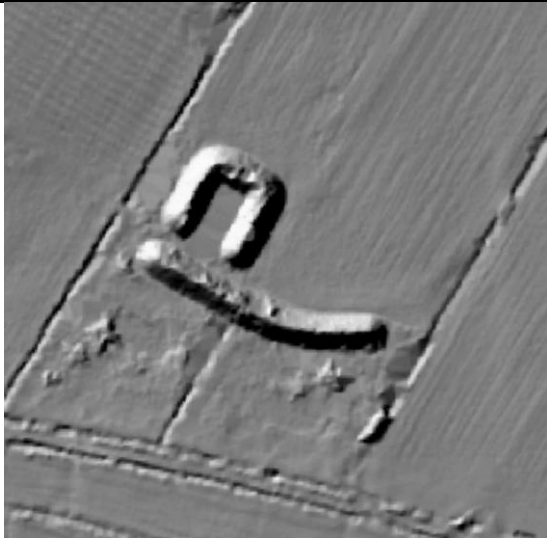
<p>ID: 7</p> <p>Description: Large bund with no track surviving. Bund shown on historic AP.</p> <p>Condition: good</p>

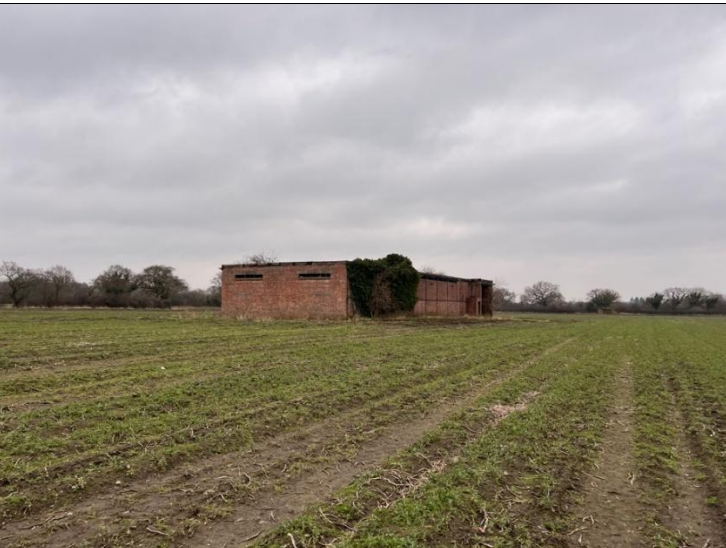
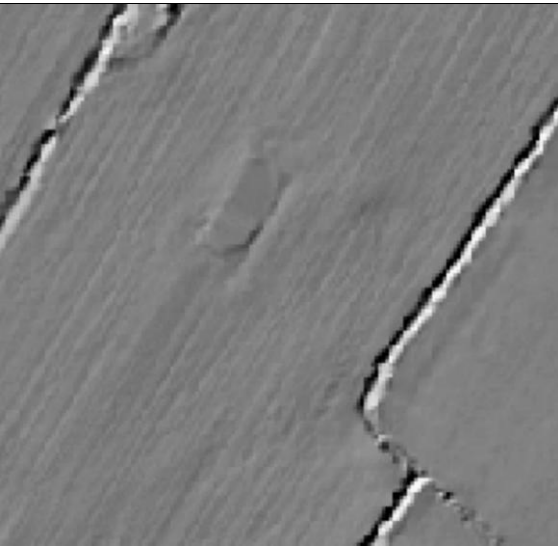
<p>ID: 8</p> <p>Description: no bund with no tracks (no bund on historic AP).</p> <p>Condition: poor/fair overgrown</p>

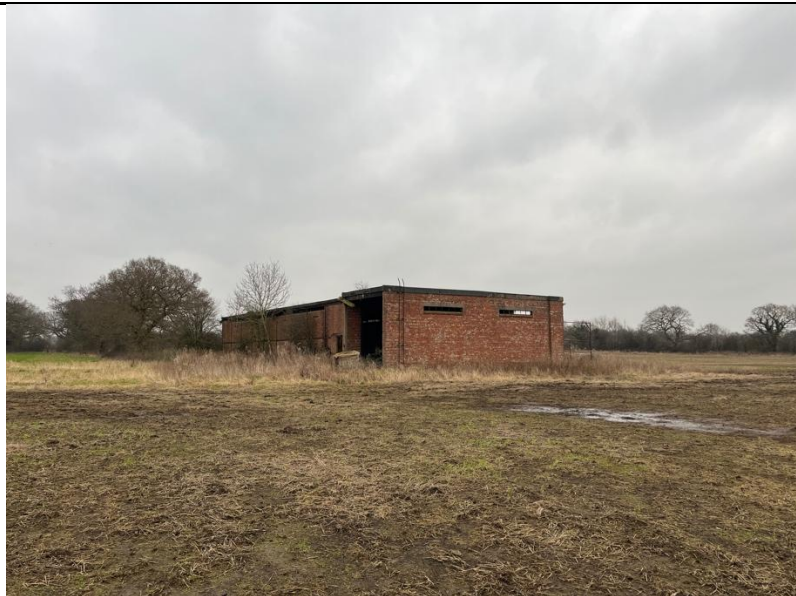
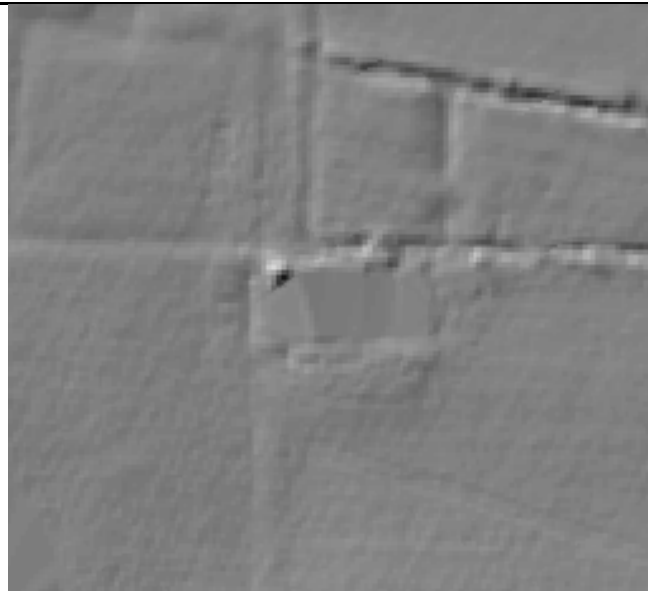
ID: 11

Description: no bund, internal rail tracks in situ (no bund on historic AP).

Condition: good

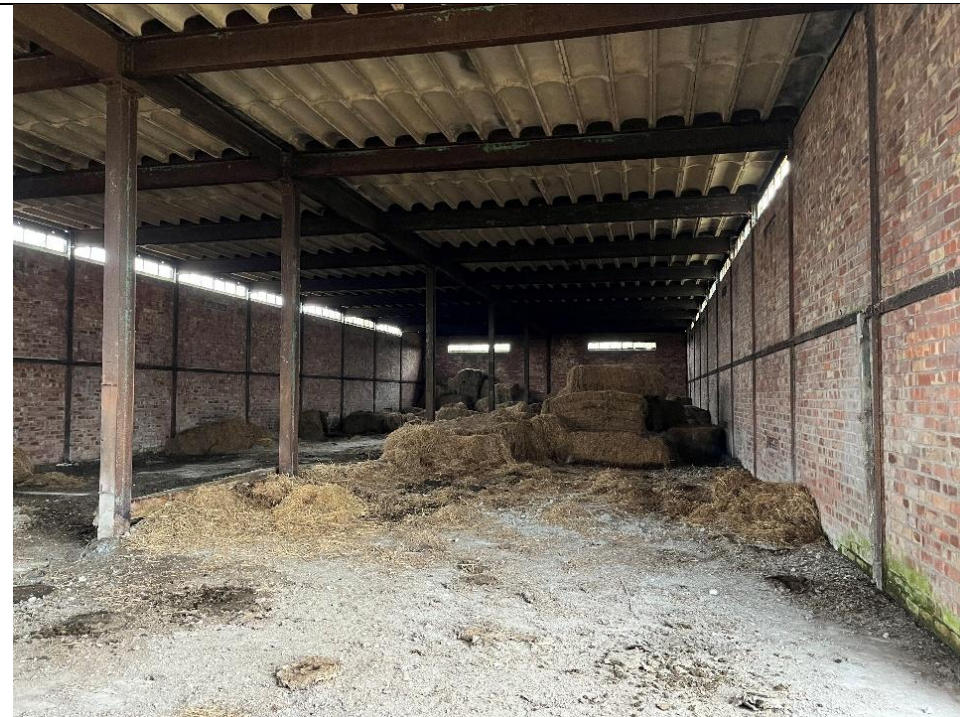
Internal photograph of Building 9

<p>ID: 9</p> <p>Description: no bund, but internal rail tracks in situ. This store is shown to have a bund on historic AP but none is extant now. The blast wall is intact.</p> <p>Condition: poor</p>
 	 	<p>ID: 10</p> <p>Description: no bund, internal rail tracks in situ (no bund on historic AP).</p> <p>Condition: poor – overgrown, holes in walls</p>

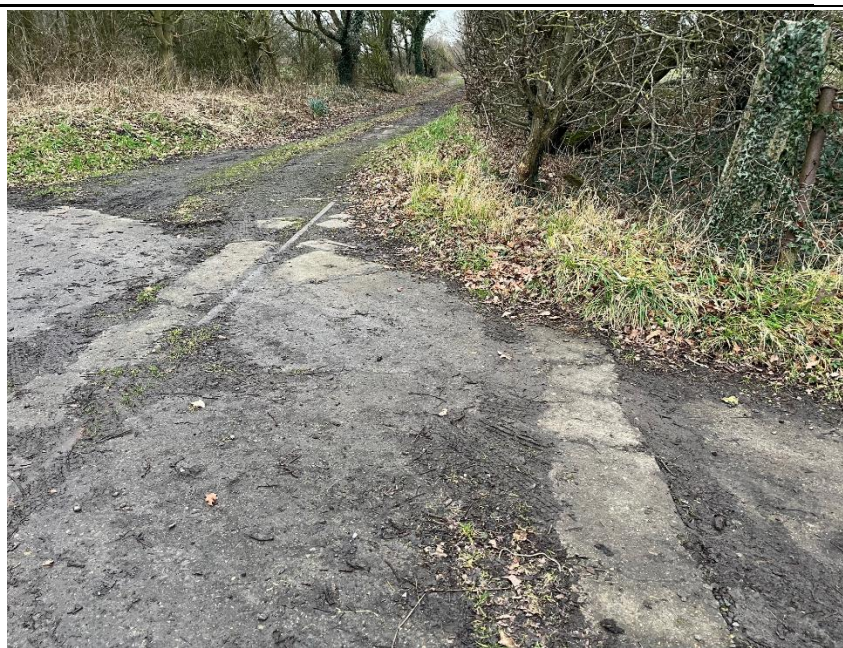
Photograph showing rail track
